Localised geomorphic response to channel-spanning leaky wooden dams

Abstract. The introduction of leaky wooden dams (or engineered log jams or LDs) into river corridors in low-order streams in upper catchments has recently become a popular form of natural flood management, particularly in NW Europe. LDs are designed to emulate processes such as those of naturally occurring large wood in river systems, aiming to reduce downstream flood risk through the attenuation of water during higher flows, decreasing in-channel velocities and increasing channel–floodplain connectivity. LDs effectively act as channel roughness agents that disrupt the fluvial and hydrological regime and attenuate the peaks in high river flows, thus mitigating downstream flood risk. Despite their widespread installation, there is a paucity of data and understanding concerning the longer-term fluvial geomorphological response to LD installation. Here we present a detailed quantification of both the geomorphic and sedimentary response to the installation of two LDs in a catchment in Dalby Forest (North Yorkshire, UK) using high-resolution terrestrial laser scanning and detailed bathymetric surveys over a 2.5-year pe

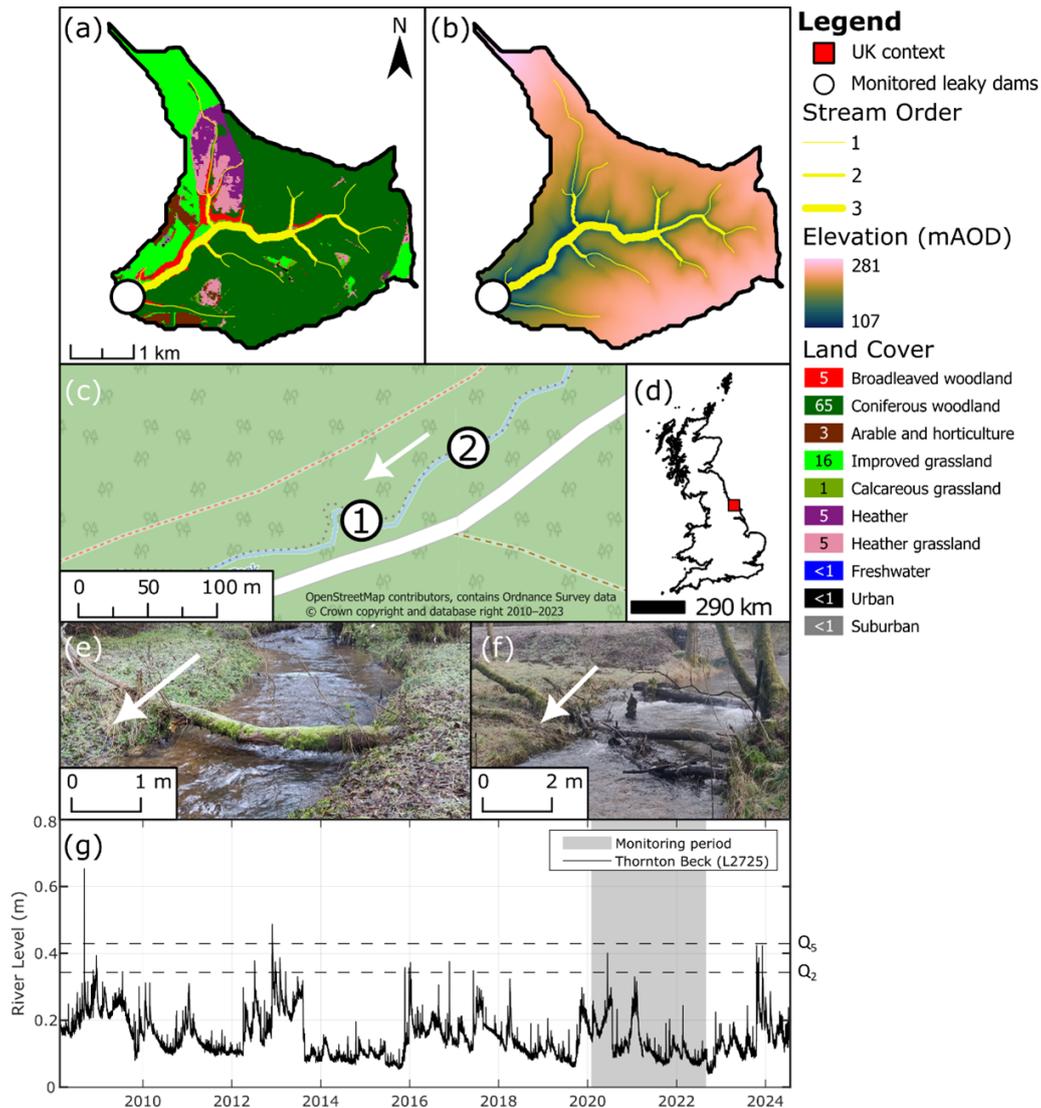
Figure 1. Location of the studied LDs in relation to the Dalby Forest catchment. (a) 2021 land cover map with percentage cover shown in the legend (Marston et al., 2022). (b) Stream network generated from terrain data showing Strahler stream order and elevation (Ordnance Survey, 2020). Note the same scale as panel (a). (c) Location of LD1 and LD2, with the flow direction denoted by a white arrow. (d) UK context for the site location. (e, f) LD1 and LD2, respectively, with the flow direction denoted by a white arrow. (g) River-level record 2008–2024 for Thornton Beck, Thornton Le Dale (Grid Reference: SE 83681 83418; Station ID: L2725), approximately 7 km downstream of the study area (from the Environment Agency) including the estimated return period (Q_n), as described in the Supplement.

The catchment is characterised by woodland (70 %), with grassland (17 %) and heather (10 %) being the other principal land use types (Marston et al., 2022), as shown in Fig. 1a. It has a mean annual precipitation of 980 mm, with monthly averages ranging from 55.6–118.9 mm (1991–2020 mean, Fylingdales weather station at 262 mAOD, 11.2 km NE; Met Office, 2020). The catchment contains 17 km of river corridor, with a mixture of first- (9.9 km), second- (3.6 km) and third-order (3.5 km) streams, following the Strahler (1957) stream-order notation (Fig. 1a, b). The channels are between 1 and 4 m wide, widening towards the catchment outlet.

LD1 (Fig. 1e) is a channel-spanning LD anchored in situ with a wooden stake on the true right bank to reduce the likelihood of displacement during high flows; it was embedded into the surface on the true left bank. The channel was 2.7 m wide where the LD was installed. The structure was comprised of a single log which was fully separated from a tree trunk, with some thin branches attached facing upwards. Since this LD is fully channel spanning and thus does not interact with baseflow, it is a “Type 1” LD (fully channel spanning, not interacting with baseflows) following the classification of Lo et al. (2021).

LD2 (Fig. 1f) was felled and left in situ, remaining attached to its stump to enable growth (a “living” LD). The LD itself was composed of two sub-sections, with the furthest downstream (LD2a) spanning a 3.85 m wide channel. The structure was partially submerged at the time of installation. LD2a was classified as a “Type 2” LD (fully channel spanning, interacting with baseflows but not touching the stream bed; Lo et al., 2021). LD2 was more complex than LD1 due to the presence of a pre-existing walkway that formed a secondary sub-structure LD2b that was fixed with wooden anchors. LD2b was a “Type 1” LD (fully channel spanning, not interacting with baseflows at all; Lo et al. (2021)). LD2b was installed above the average water depth and spanned a 3.25 m wide channel.

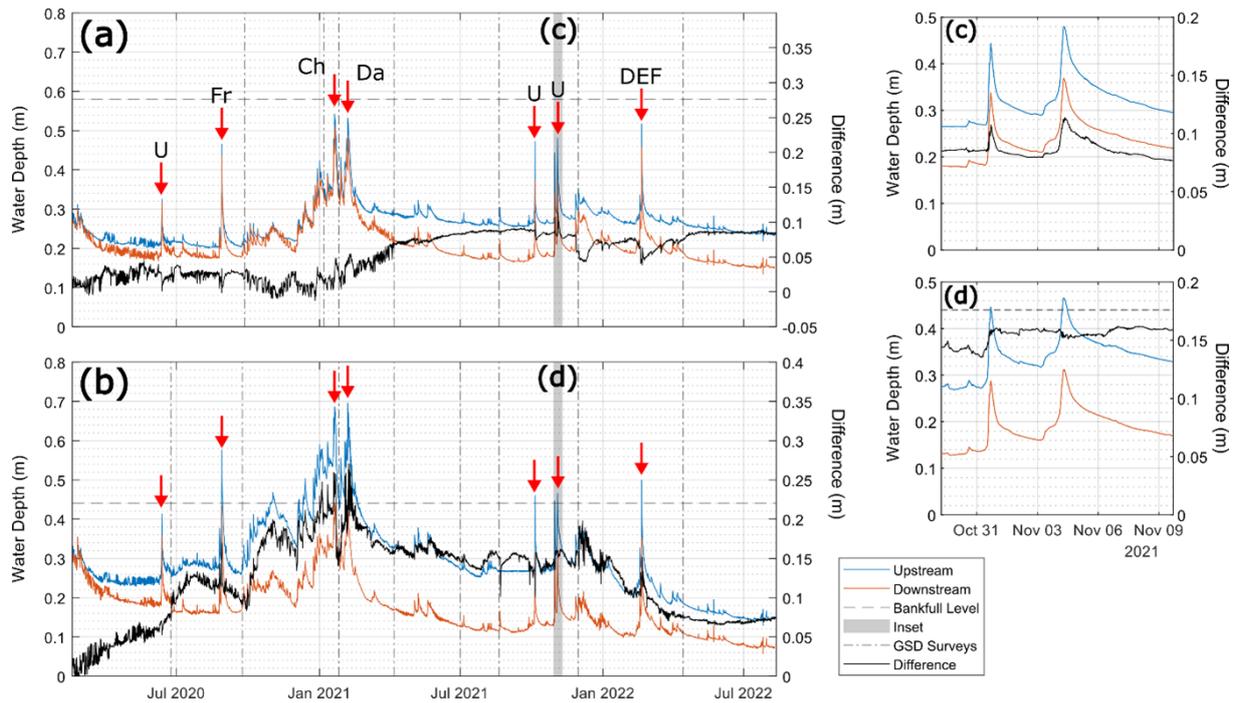
Figure 2. Temporal variations of water depth for LD1 (a) and LD2 (b) with differences between upstream and downstream recordings shown, as well as key peaks and storms (U = unnamed, Fr = Francis, Ch = Christoph, Da = Darcy, DEF = Dudley, Eunice, and Franklin). Also shown are the dates of the GSD surveys and bankfull level. Note the different secondary y-axis scale. Panels (c) and (d) show variations in the water depth throughout time between the two sites.

The average water depth at site 1 was 0.26 and 0.21 m (up- and downstream, respectively). The bankfull depth was 0.58 m. However, the flow did not engage with LD1 at this site, nor did the channel exceed its banks during the monitoring period. Note that the reported depth values are higher than the LD1 vertical gap size due to their installation locations. The maximum depth was 0.54 m upstream of LD1 and 0.51 m downstream during Storm Christoph (21 January 2021; estimated RI of 2.3 years). In contrast, the average water depth at site 2 was 0.29 and 0.17 m (up- and downstream, respectively). The bankfull depth was 0.44 m and was exceeded upstream for a total of 69 d (7.6 %) of the monitoring period, but not downstream. The true right bank became partially inundated and the flow outflanked LD2b, resulting in increased scour immediately downstream of LD2b, limiting the maximum capacity of the structure during these bankfull periods. The maximum recorded depth was 0.67 m upstream and 0.44 m downstream during Storm Darcy (7 February 2021), with a RI of 1.61 years. Seven storm events occurred during the monitoring period, denoted by red arrows in Fig. 2 linked to key storms identified in Table 1, that resulted in near exceedance or exceedance of the bankfull stage at site 2, in addition to increased average water depth throughout winter 2020/21 observed at both sites.

Initially, water depths at LD1 covaried, averaging 0.21 m downstream and 0.22 m upstream between February 2020 and November 2020, increasing to 0.31 and 0.32 m, respectively, until February 2021, when the upstream depth diverged from the downstream. Throughout the monitoring period, there was an average difference of 0.05 m and a maximum difference of 0.11 m between the two depths, with the upstream depth ranging from 0.20 to 0.54 m, and the downstream depth ranging from 0.13 to 0.51 m.

In contrast, the upstream and downstream water depths quickly diverged at LD2, with an average difference of 0.12 m between the upstream and downstream depths. The downstream peaks were generally shorter in duration than the upstream (Fig. 2b) due to water being stored upstream and slowly released, extending the peak. Additionally, once the LD was fully engaged with the river, there was a near constant difference between the downstream and upstream depths of up to 0.27 m. This difference decreased to less than 0.10 m following the last notable storms of the monitoring record in February 2022 (Dudley, Eunice, and Franklin). The upstream and downstream depths ranged from 0.13 to 0.70 m and from 0.06 to 0.44 m, respectively.

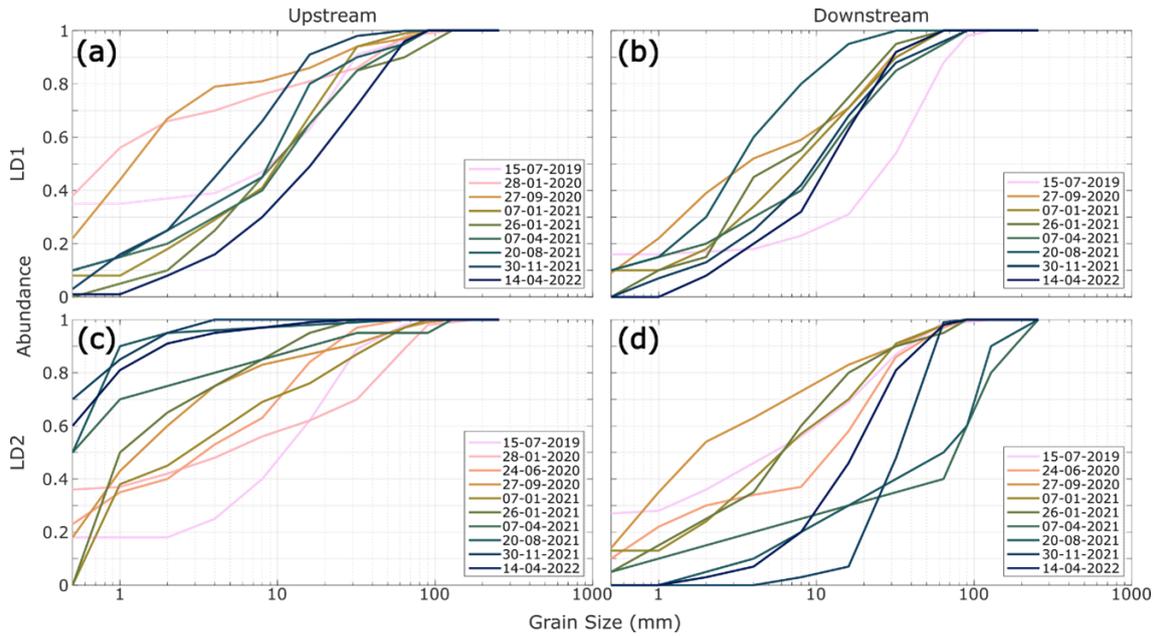
Figure 3. Cumulative density functions of the Wolman pebble count data at LD1 (a, b) and LD2 (c, d). The sites are separated into upstream (a, c) and downstream (b, d) observations.

tions upstream of the structure immediately following installation and until September 2020, the between-event variability was greater than any consistent change to the GSD at LD1 during the monitoring period, although there is some evidence of slight coarsening over the longer record (Fig. 3a, b). In contrast, fine sediment was deposited upstream and scoured downstream at LD2. This was reflected in a consistent fining trend upstream of the structure post-installation, resulting in a decrease of D_{50} from 10 to < 1 mm (Fig. 3c) and a consistent coarsening trend downstream of the structure, resulting in an increase of D_{50} from 5 to 30 mm (Fig. 3d).

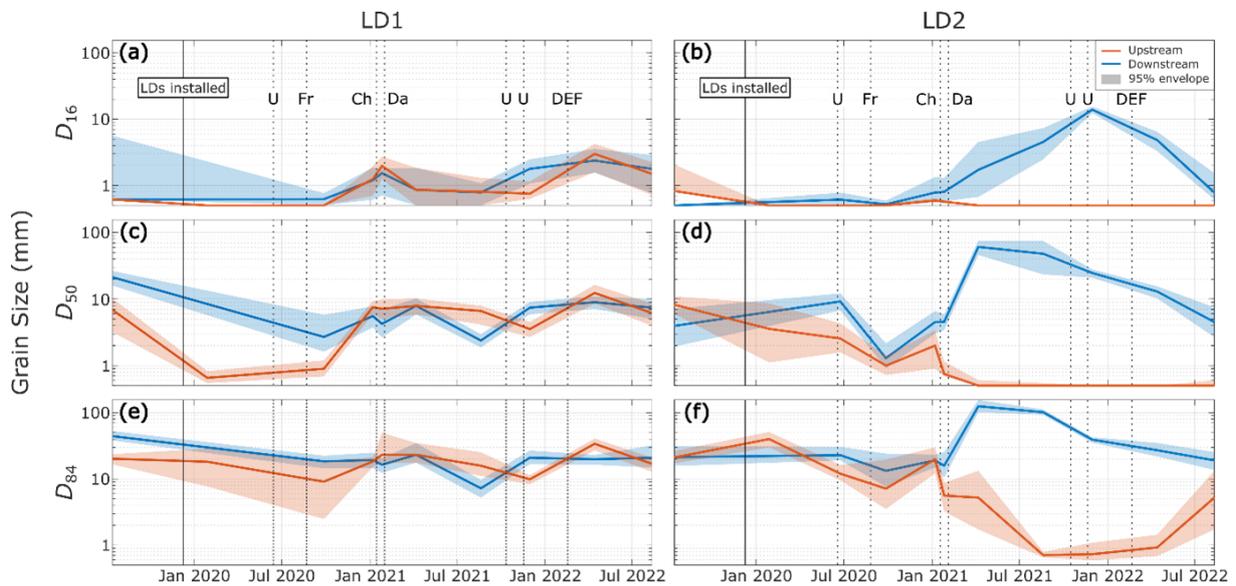
Figure 4. GSD metrics for upstream (orange) and downstream (blue) of the LD structures, with the 95 % error envelope shown. Key storms are indicated by dashed vertical lines.

D_{50} and D_{84} highlight the variability between the two sites as well as upstream and downstream of the LD structures, as shown in Fig. 4. LD1 showed little difference for all metrics, with upstream and downstream matching closely throughout the monitoring period, often within the calculated 95 % confidence interval of the measurements themselves. As such, this aligns with the more detailed GSD overview presented in Fig. 3. In contrast, the metrics for LD2 diverge notably from January 2021 onwards following the wet 2020/21 winter and storms Christoph (RI = 2.3 years) and Darcy (RI = 1.6 years), with downstream coarsening and upstream fining. There was a maximum range of 59 mm for D_{50} in April 2021, 98 mm for D_{84} in August 2021, and 10 mm for D_{16} in November 2021. At the end of the monitoring pe-

riod, all the grain-size metrics converged, most notably upstream of LD2, where D_{84} coarsened to 5.5 mm following winter 2021/22, while D_{16} and D_{50} downstream of the LD both fined to < 1 and 5 mm, respectively, from peaks of 10.5 and 60 mm.

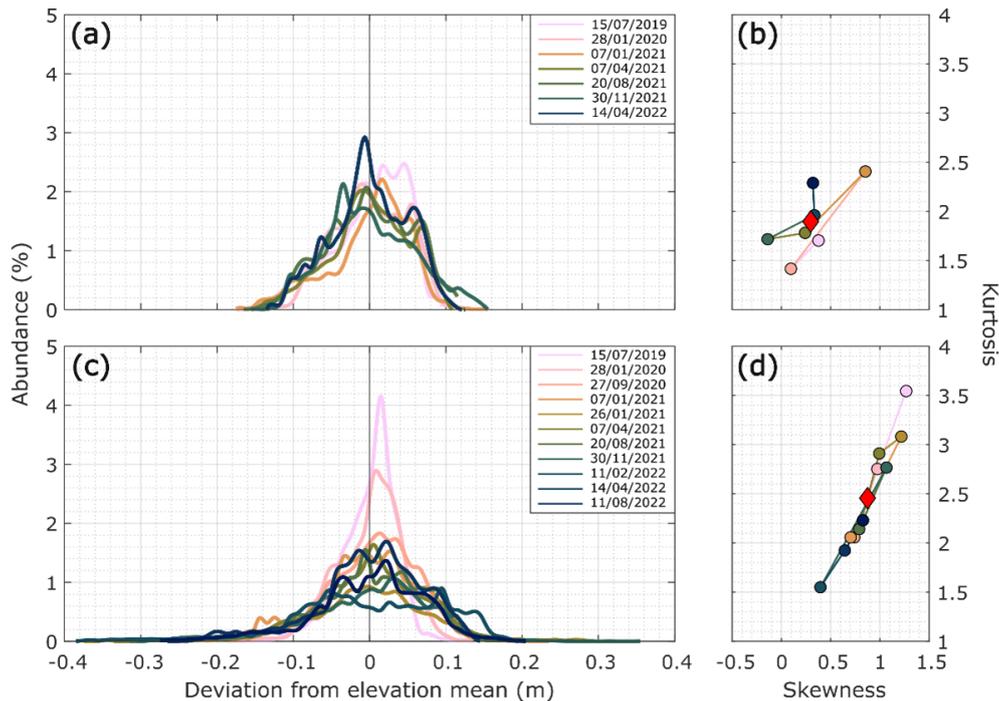
Figure 5. Detrended surface elevations relative to the mean for each bathymetric survey for LD1 (a) and LD2 (c). The associated skewness and kurtosis for each date are also shown with the mean shown as a red diamond (b, d).

In contrast, LD2 (Fig. 5c) exhibited increased topographic variability throughout time, with a minimum bed elevation range of 0.3 m in July 2019 and a maximum of 0.58 m in February 2022 following storms Dudley, Eunice, and

Franklin. The distribution evolved temporally from one that was predominately above the elevation mean with little variability (i.e. skewness > 1, kurtosis > 3.5; Fig. 5d) to a flatter, wider distribution with up to 0.38 m of deviation from the mean (February 2022), highlighting the development of plunge and underflow pools beneath LD2 (Fig. 7c, d). There was a clear progression throughout time from the pre-LD survey in July 2019, stabilising following the wet winter in Jan-

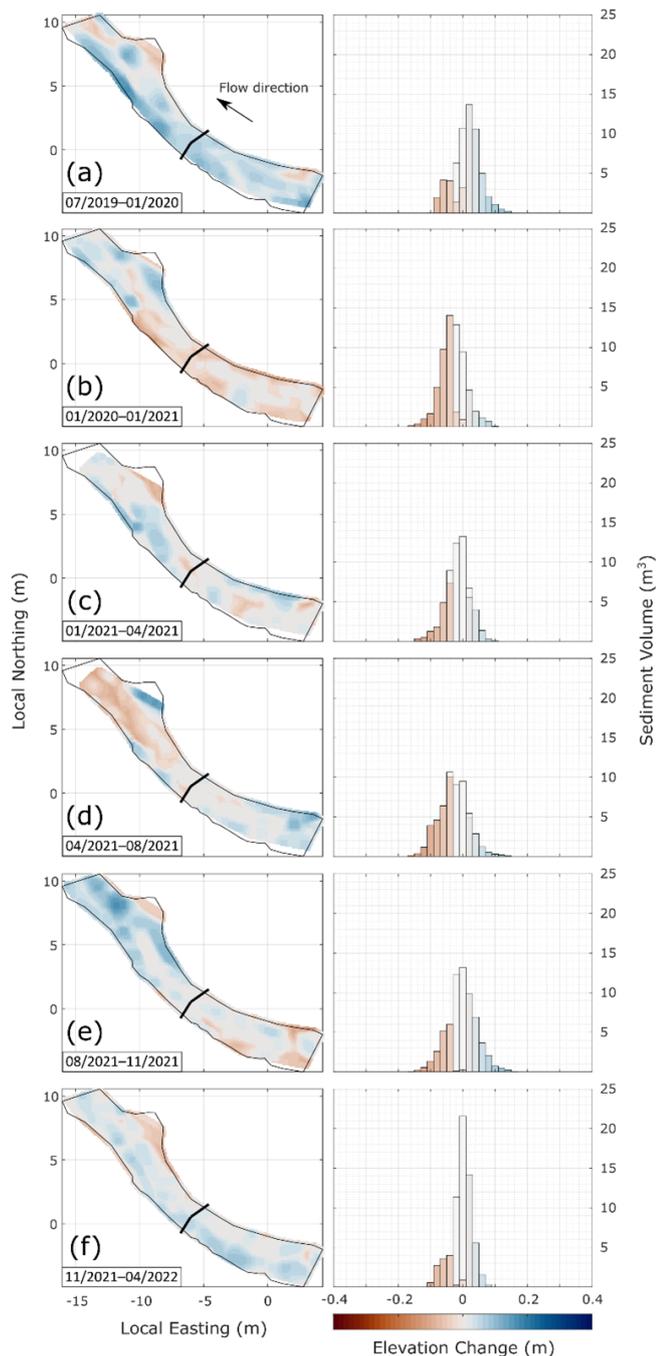
Figure 6. DoDs for LD1 (left column) and histograms of elevation change (right column). Significant elevation change ($\alpha < 0.05$) is denoted by colour (red is erosion, blue is deposition), with insignificant change shown in grey. The channel boundary is shown as a black outline, with the planar view of the LD represented as a thick black line.

ability remained unchanged throughout the monitoring period. There was also no generation or removal of existing bedforms, and the bed elevation change was likely not influenced by the LD, as further shown in Fig. 6.

LD1 exhibited a maximum scour depth of 0.16 m between January 2020 and November 2021 (Fig. 6b–e) which was distributed throughout the reach, both upstream and down-

stream of the LD. There was a maximum deposition depth of 0.14 m between April and November 2021 (Fig. 6d, e), situated approximately 5 m downstream of the LD. The range of elevation change did not fluctuate greater than ± 0.04 m throughout time. Spatially, most of the change was situated greater than 5 m from the LD, with the change around the LD being below the LoD threshold.

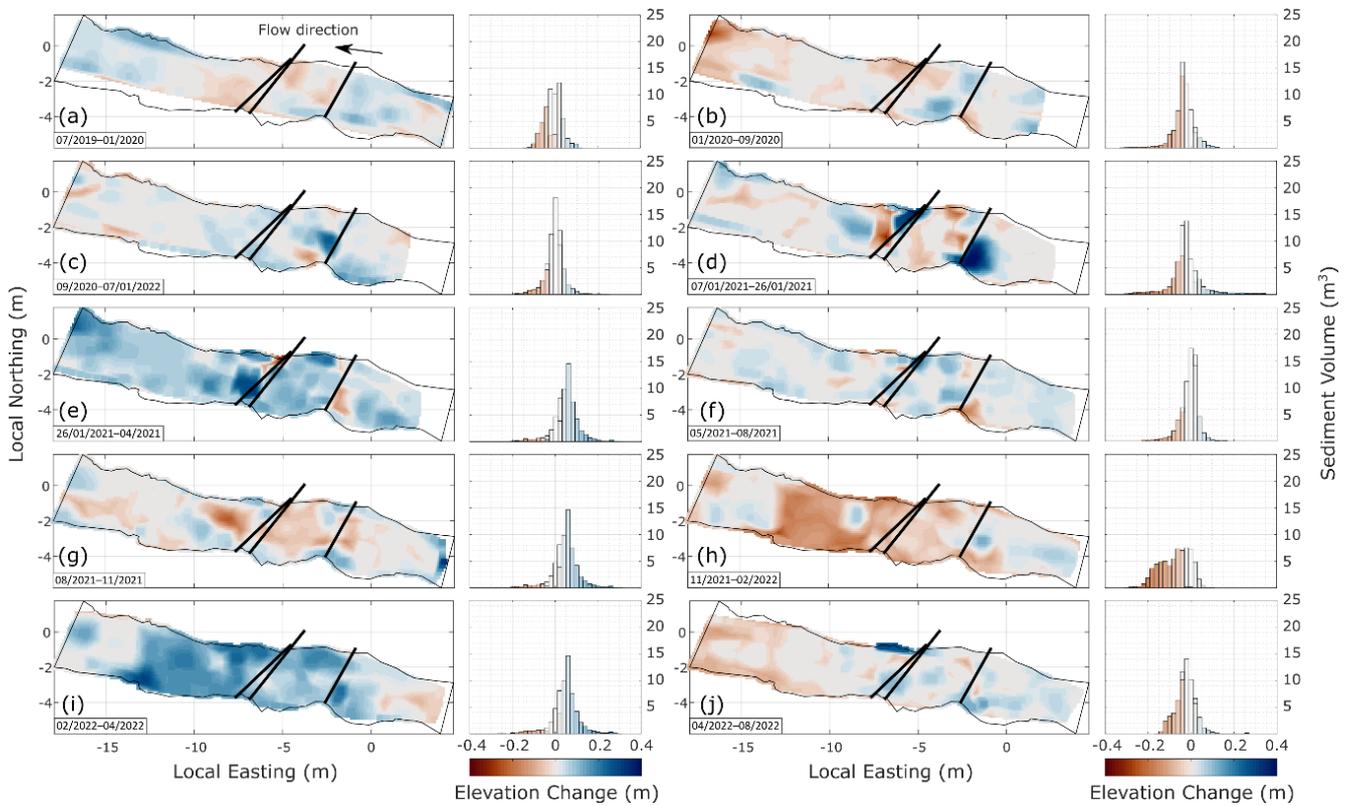
Figure 7. DoDs for LD2 (left column) and histograms of elevation change (right column). Significant elevation change ($\alpha < 0.05$) denoted by colour (red is erosion, blue is deposition), with insignificant change shown in grey. The channel boundary is shown as a black outline, with the planar view of the LD represented as a thick black line. The flow direction is denoted by a black arrow in panel (a).

LD2, which was formed by two linked structures, had a maximum scour depth of 0.38 m between 26 January 2021 and April 2021 (Fig. 7e) and a maximum deposition depth of 0.4 m (7–26 January 2021; Fig. 7d). The range of elevation change fluctuated throughout time from -0.14 – 0.12 m immediately after LD installation (July 2019–January 2020; Fig. 7a) to reported maximum values. Additionally, the DoDs were highly spatially variable, with evidence of pool formation downstream of the lower LD (Fig. 7a, b), which experienced periodic infilling (Fig. 7c, d) and scour (Fig. 7e, h) throughout the monitoring period. Immediately downstream of the upstream LD2a, a secondary pool formed that exhibited similar scour and fill cycles. The upstream LD2a stored sediment during the monitoring period, most clearly illustrated by Fig. 7d (7–26 January 2021 following Storm Christoph), where a substantial area of the DoD exhibited change greater than the LoD. The depositional zone also fluctuated over time, infilling and scouring on the true left bank of LD2a.

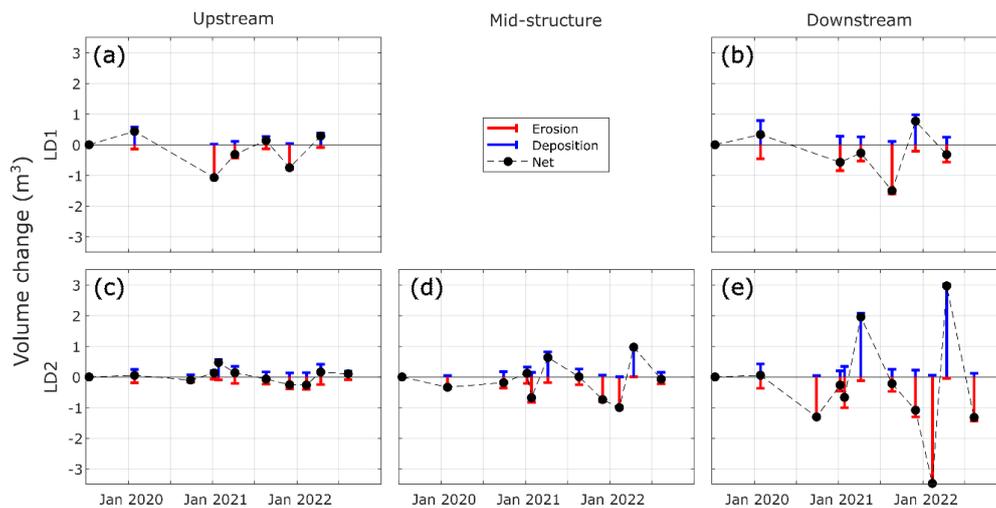
Figure 8. The volumetric change split into erosion and deposition for LD1 upstream (a) and downstream (b), and LD2 (c–e), separated into upstream of LD2b (c), mid-structure (i.e. between LD2a and LD2b; (d)) and downstream of LD2a (e).

Upstream of LD1, the volumetric change was highly variable (Fig. 8a), with no greater than 0.6 m^3 of deposition im-

mediately after the LD installation and 1.1 m^3 of erosion in January 2020. The upstream net change fluctuated throughout the monitoring period, with increased scour following higher flows in winter and increased deposition across sum-

mer period lower flows. Downstream of LD1 exhibited a similar pattern (Fig. 8b) but there was increased erosion (a maximum of 1.6 m^3 in August 2021) and deposition (up to 1 m^3 in November 2021).

Upstream of LD2 there was a clearer temporal trend (Fig. 8c). There was a maximum deposition of 0.6 m^3 on 26 January 2021 and increased erosion (0.4 m^3) following higher flows in February, with a clear progression as less sediment was being stored throughout the year. The LD impounded sediment upstream (Fig. 7d) and scoured over the following year prior to infilling again. Although the range of volume change was smaller than upstream of LD1, there was clearly a progression linked to the presence of the LD. There was more variability mid-structure at LD2, ranging from a maximum of 1 m^3 of erosion between January and February 2022 and 1 m^3 of deposition between February and April 2022 (Fig. 8d), reflecting pool formation and cyclic scour and infilling between the two LDs (see also Fig. 7a–d). Downstream of the LDs also exhibited similar variability (Fig. 8e), where plunge pools developed immediately downstream of the structure near the true right bank, followed by deposition further downstream. This section had the greatest range of volume change, with up to 3.4 m^3 of erosion between February and April 2022 and 3.0 m^3 of deposition between January and February 2022. Spatially, these periods were less variable as there was reach-wide erosion and deposition. However, there were localised areas 1 m downstream of the LD that exhibited little elevation change.

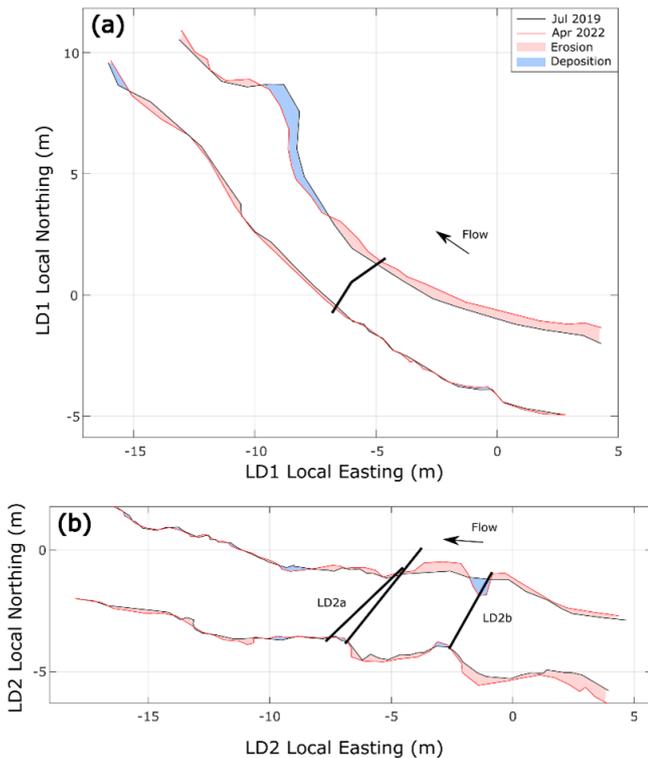
Figure 9. Bank erosion and deposition for LD1 (a) and LD2 (b). LDs are represented as thick black lines.

The banks at LD1 (Fig. 9a) predominantly exhibited erosion upstream of the LD and deposition downstream. The true right bank experienced 2.4 m^2 of bank erosion and 4.8 m^2 of deposition, with a net areal change of 2.4 m^2 (Table 3). In contrast, the true left bank at LD1 predominantly exhibited erosion, experiencing -1.9 m^2 of bank loss, 0.41 m^2 of deposition, and -1.5 m^2 of net areal change. The overall net planform area change at LD1 was 0.90 m^2 . The channel at the site is relatively straight, and there was no clear influence from LD1 on bank erosion since the true right bank had a similar magnitude of planform change both above and below the LD.

LD2 (Fig. 9b) predominantly exhibited erosion, with a net planform area change of -1.10 m^2 but with greater spatial variability near the LD sequence. Immediately downstream of LD2b on the true right bank was an area of deposition, followed by approximately 0.50 m^2 of bank erosion, flanking LD2b. A similar pattern was observed on the true left bank, with an area of erosion upstream of LD2b, and a small area of deposition downstream. Often during high flows, the river would exceed the riverbanks – as highlighted above – and flank the true right bank of LD2b. This clearly resulted in localised scour downstream of LD2b on the true right bank. LD2a appeared to have had little impact on the banks, de-

spite retaining water. Deposition mainly occurred in the mid-structure, preceded and succeeded by bank erosion. There was less apparent impact from LD2a downstream (Fig. 9b) as, despite having increased structural complexity, the structure engaged with deeper flows less frequently than LD2b.
