Connectivity in forested upland catchments and associated channel dynamics: The eastern Ruahine Range. Journal of Hydrology (New Zealand), 50 (1). pp. 205-226.

# Connectivity in forested upland catchments and associated channel dynamics: The eastern Ruahine Range

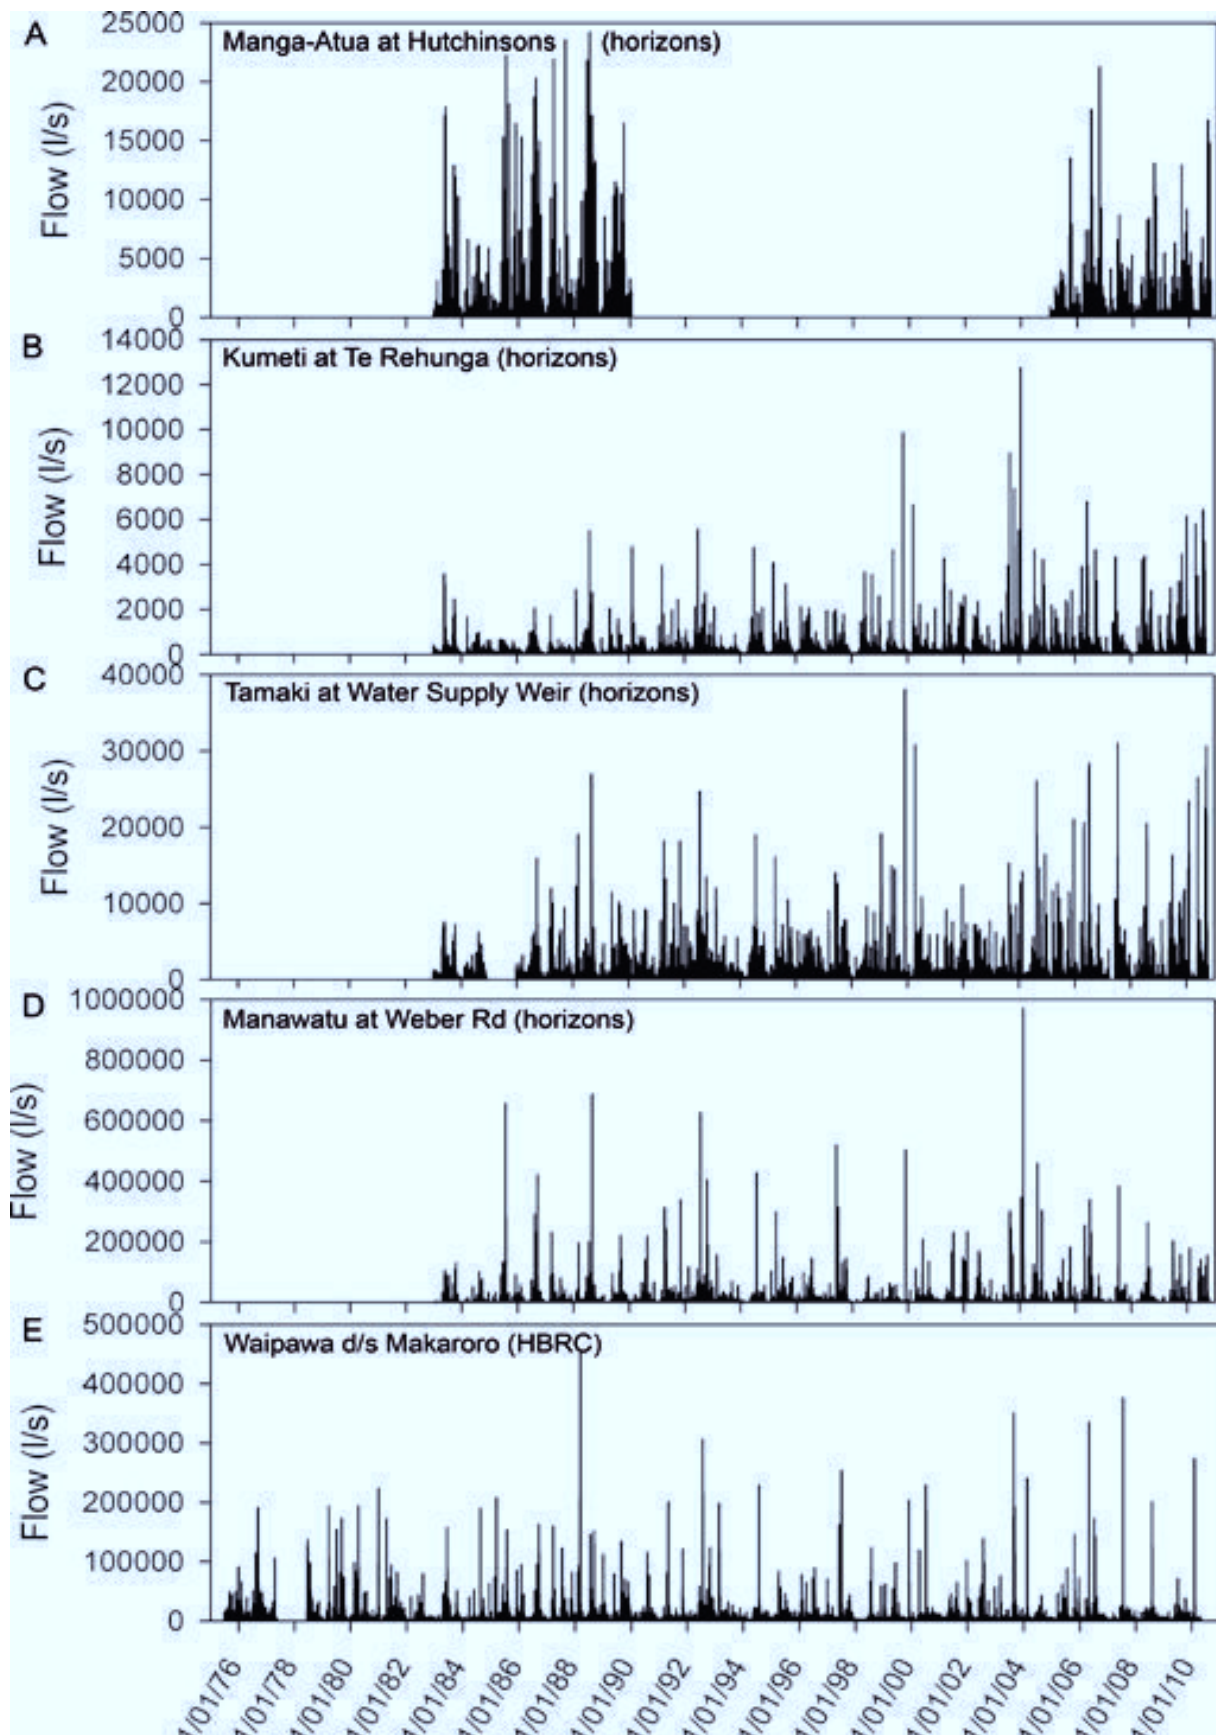
**Figure 4** – Flow hydrographs from gauges downstream of the study reaches: (A) Coppermine, (B) Mangapuaka, (C) Tamaki, (D) Manawatu and (E) Waipawa. Flow data were provided by Horizons and Hawke’s Bay Regional Councils.

The Manawatu and Coppermine reaches showed only small patches of scour or fill (Fig. 2B, C and 3B, C) and thus relative stability. Most parts of the Manawatu and Coppermine channels were armoured. Although floods occurred during both periods (Fig. 4A and D), they did not cause identifiable morphological change.

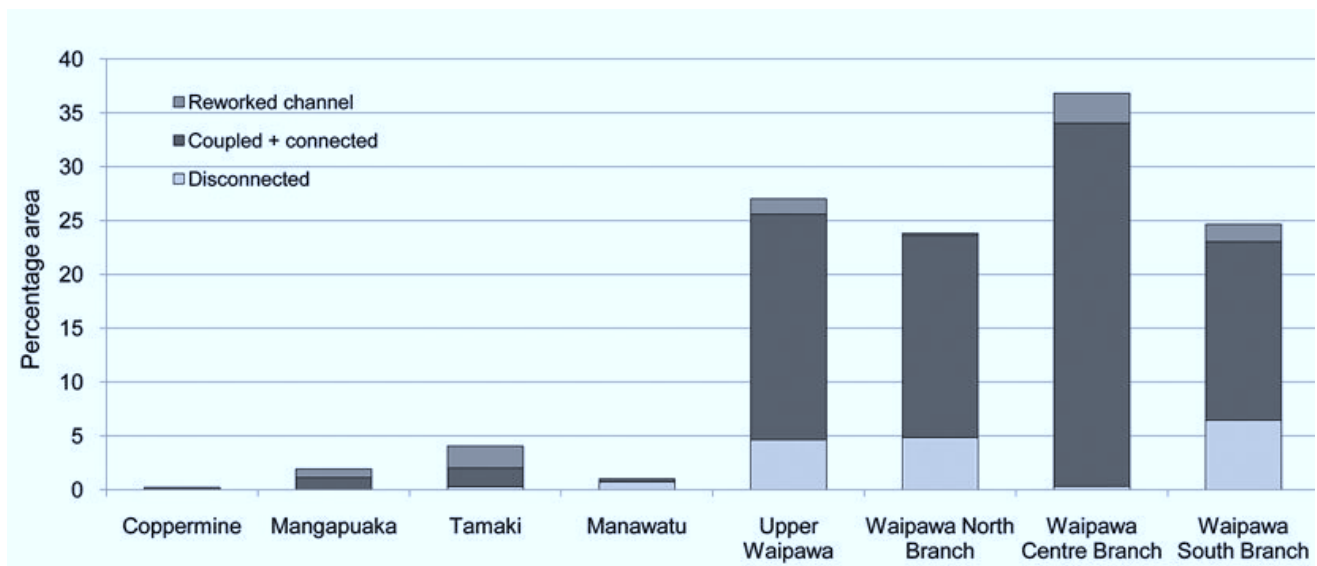
**Figure 5** – Percentage of catchment area subject to erosion or reworking, coupled and connected, or disconnected from the study reach at five mountain stream catchments in the eastern Ruahine Range.

The Coppermine catchment comprises only 0.2% eroded area, 89% of which was coupled to the main channel and connected to the study reach (Table 1, Fig. 5). The slips were mainly isolated and ephemeral features (Fig. 3A). Since 2005, additional shallow slides or slumps were initiated, but the coupling of coarse material to the channel was limited. No reworked dry channel substrate was identifiable from aerial photos. Most of the tributaries were of low significance according to their relative area and comparatively low slope (Table 3).

The South Branch drains the largest of the three upper sub-catchments. Landslides and gully erosion occupied 23% of the planimetric catchment area (Fig. 5). Of this eroded area, 72% or 0.425 km<sup>2</sup> (Table 1) was coupled to the channel. In particular, the true-left headwater gullies and slopes were highly active, frequently supplying

The Centre Branch has the smallest area of the three upper sub-catchments. It consisted of 34.1% eroded area, of which 99% was connected to the channel (Fig. 5). The entire east-facing slopes of Te Atuaoparapara can be described as a large gully complex with a

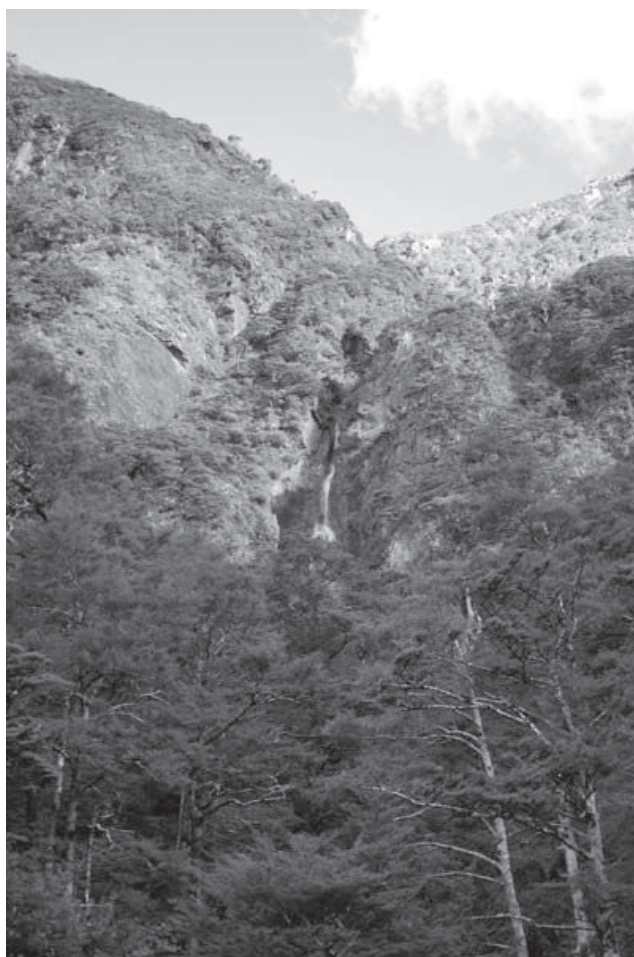
**Figure 11** – Unconnected true-left tributary in the Waipawa South Branch catchment with bedrock constrictions that prevent regular coarse sediment transport and cause a waterfall.
