Meander chute cutoff at an alluvial river facilitated by gypsum sinkholes

Schwendel A. C.¹, Cooper A. H.²

Key words: subsidence, collapse doline, gypsum karst, gravel-bed river, photogrammetry, lidar

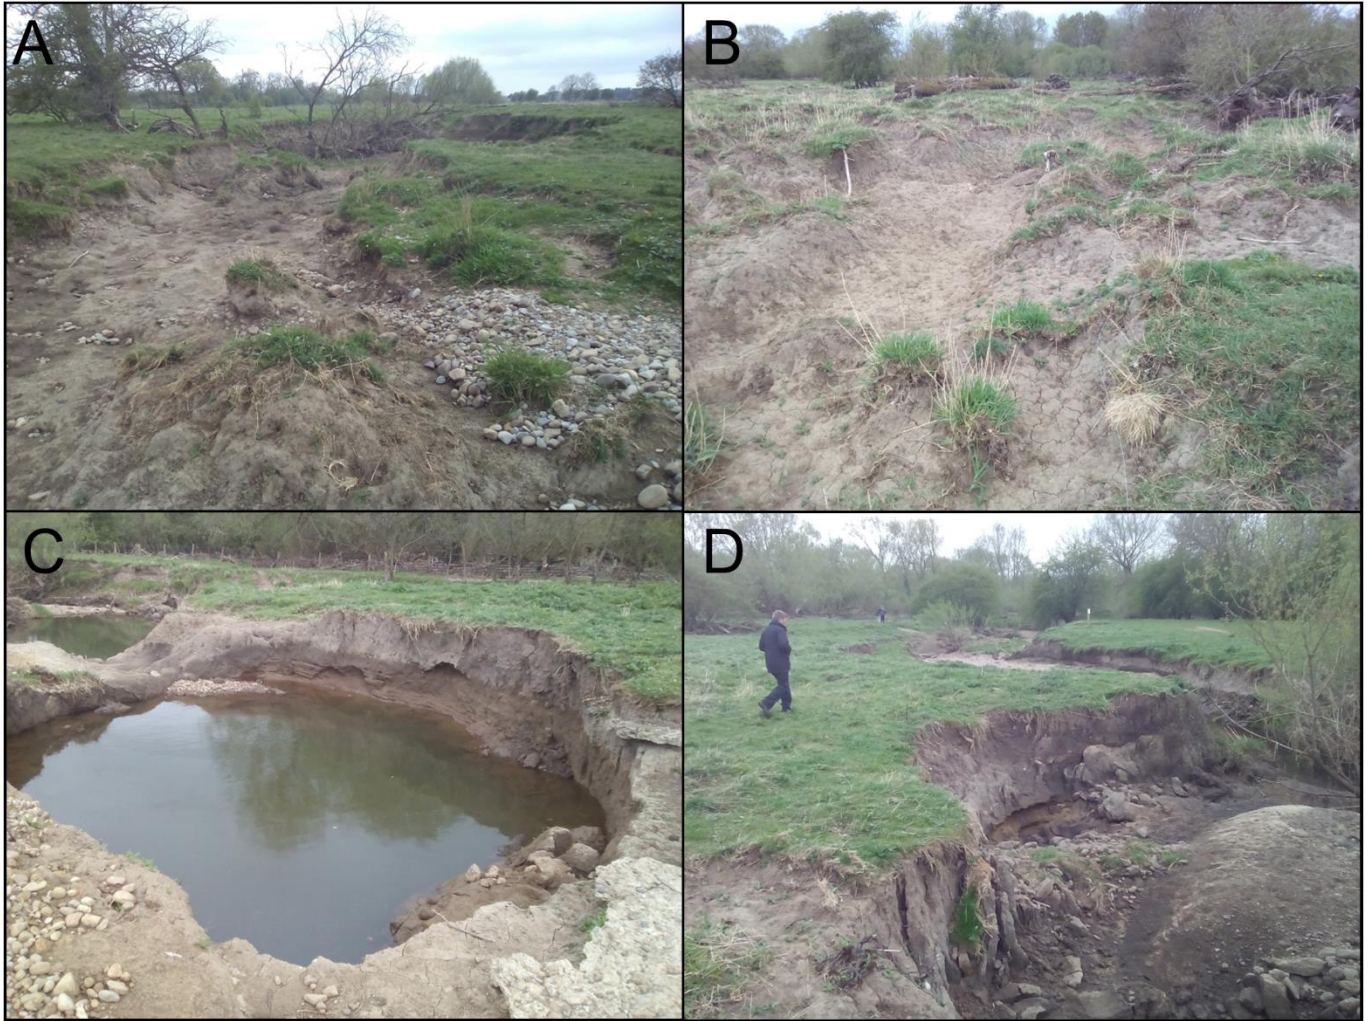
Figure 10. Photos of Ripon Loop before cutoff (April 2019). (A) View in northerly direction towards sinkhole group G2 with superficial erosion channel from overbank flows in the foreground. (B) View in southerly direction from the head of the future chute channel towards sinkhole group G2 (same fallen tree in top right as visible in panel A) showing multi-thread superficial erosion scoured by flood waters since 2012. (C) New sinkhole subsided after 2015 associated with group G3 and group G5 in the background viewed from the same position as the photo in panel A but in south-westerly direction. Cobbles from overbank flows are visible at the downstream end and on floodplain in the foreground. Thick channel deposits are exposed on the edge of G5 while a thin cemented layer of cobbles at shallow depth is visible in the bottom right. (D) View in southerly direction on the chain of partly coalesced sinkhole groups G5 to G8 with cobbles deposited in the down-valley end of G6 and finer sediment in the southern part of G5 in the foreground. Sinkholes groups are defined in Fig. 8.

Group G3 is first recorded as a pond on the 1892 dataset and shown with the same outline to 1957. The 1968 outline is smaller and may reflect partial filling of the hole. The 1986 data show an enlargement of the hole from 1968 and development of an irregular depression to the north which has formed into a larger depression on the 2001 lidar, while the main hole has expanded to the north-east. The 2009 lidar shows these two areas amalgamated into one large hollow, a pattern repeated on all the subsequent datasets with minor variations to 2019. Immediately west of the main hole a new sinkhole feature is visible on the 2017-2019 data, but not the 2015 lidar where only a narrow channel is shown, thus it appears to have subsided post this date (Fig. 10c).

embayments on the northern edge of some sinkholes (e.g. G2, G3 and G5) as well as narrow channels connecting them at a superficial level from 2015 show that headward incision during periods of overbank flow might have extended them as well (Fig. 10a,c). Gravel deposited by these overbank flows at the southern end of sinkholes has temporarily decreased observed sinkhole dimensions (e.g. G3, G5 and G8). By summer 2019 the sinkholes in the southern part of what became the cutoff channel (Fig. 2) had partially connected via headward erosion with low-level thresholds in between (Fig. 10c). As Ripon Loop has translated down-valley since the 1900s, the lower part of this chute channel has incised easily into relatively unconsolidated, less than 170 year old channel deposits (Fig. 2) which were well exposed in the sinkholes (Fig. 10c,d).
