A national survey of MRI safety practices in Ghana

Cite as: Albert Dayor Piersson, Philip Nii Gorleku. A national survey of MRI safety practices in Ghana. *Heliyon* 3 (2017) e00480. doi: [10.1016/j.heliyon.2017.e00480](https://doi.org/10.1016/j.heliyon.2017.e00480)

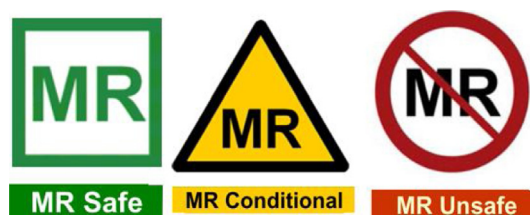
**Fig. 6.** Symbols for device labeling terms (MR safe, conditional, and unsafe).

include nonconducting, nonmetallic, and nonmagnetic items. “MR conditional”—An item that has been demonstrated to pose no known hazards in a specified MRI environment with specified conditions of use. It is identified with triangular yellow label. “MR unsafe”—An MR unsafe item is one that is known to pose hazards in all MRI environments. It is identified with circular red label.

Impressively, all respondents indicated that they check all equipment brought into the MRI suite (Table 2). This is an improvement compared to the study conducted by Opoku et al. [6] in which they reported that 75% respondents indicated they check equipment used in the MRI environment. The study also revealed that most respondents (8[67%]) indicated they have emergency exit door. However none of the respondents indicated the equipment used in the MRI suite are colour coded. The American Society of Testing and Materials (ASTM) International standard specified new terminology and symbols for identifying medical devices (see Fig. 6) for use in the MR environment to reduce MRI-associated incidents [20]. Field conditions that define the specified MR environment include field strength, spatial gradient, dB/dt (time rate of change of the magnetic field), radio frequency (RF) fields, and specific absorption rate (SAR). “MR Safe” devices poses no known hazards in all MRI environments, and they are identified with a green square. They
