Piersson, Albert and Gorleku, Philip Nii (2017) A national survey of MRI safety practices in Ghana. *Heliyon*, 3 (12). e00480.

A national survey of MRI safety practices in Ghana

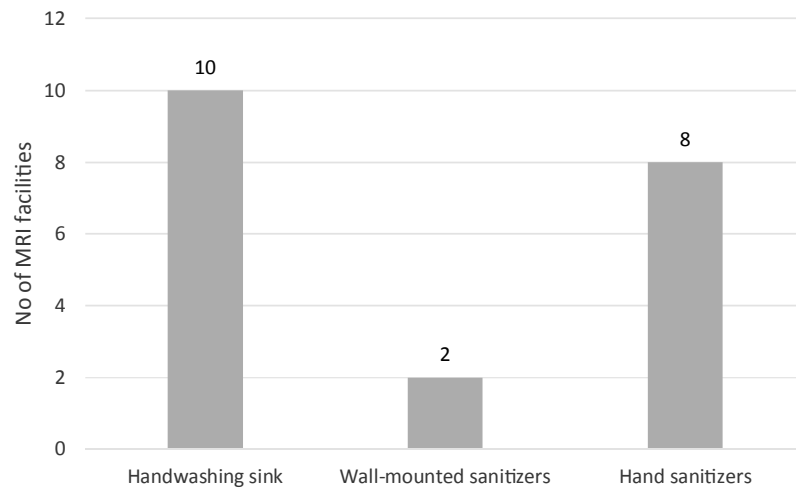
Fig. 4. Summary of Infection control practices.

The availability of hand washing sink and hand sanitizers in most facilities (Fig. 4) as indicated by the respondents is laudable. To demonstrate the importance of hand washing, the ACR [5] recommended that infection control policy be instituted in the clinical practice of MRI with consideration for hand washing stations. This is to prevent cross-infection among staff who come into direct contact with patients.
